Controlling Registration in HDI PCBs, *competitively.*

Identifying & Correcting the Specific Causes of Registration Error in High- Density PCBs.

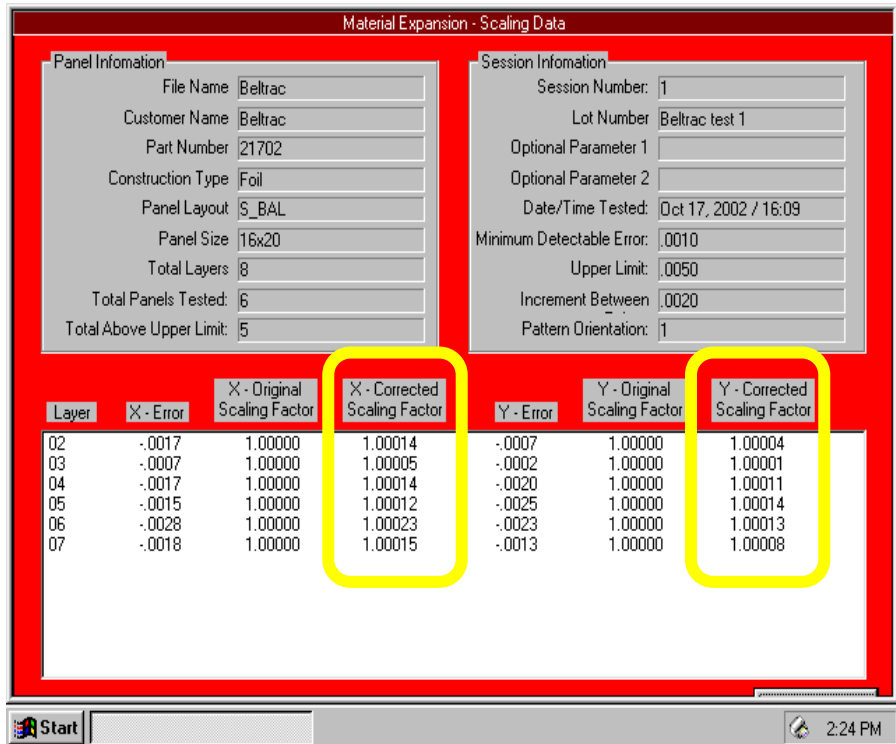
Illustration 2

When panel construction for new jobs is set up in CAM/pre-production, the software program will automatically search the database for previous jobs, **produced with the same panel construction**, and retrieve a **material expansion /shrinkage scaling report** – see illustration 2 at right.

This report will show the scale factor used for each layer on this previous job, the results produced by that scale factor, and the **corrected scale factor** for the new job, based on this data.

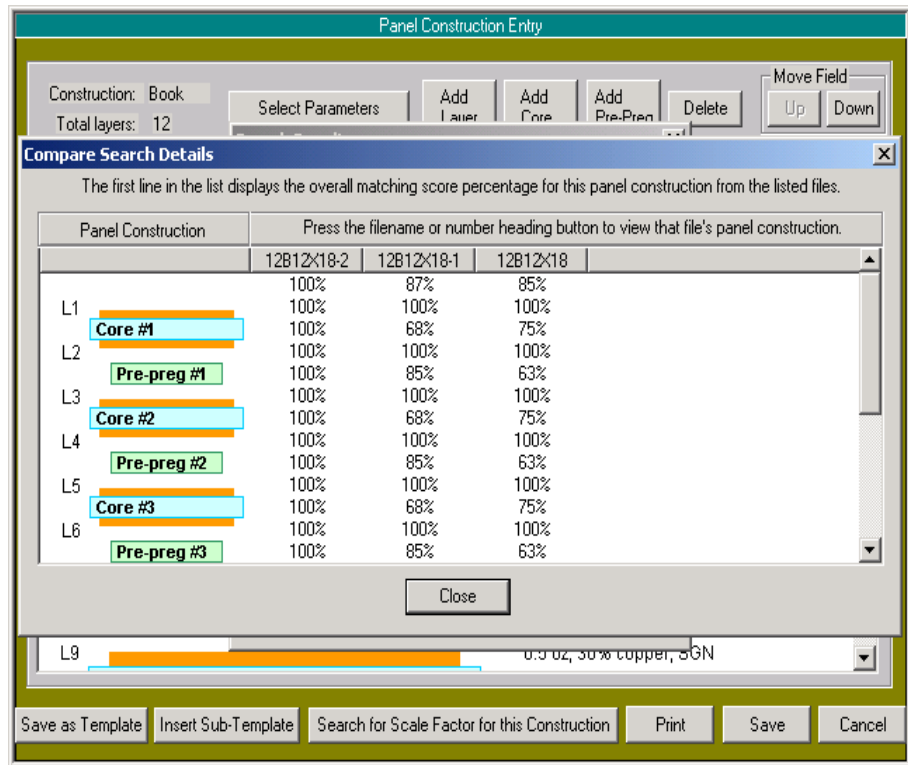
Illustration 3

If there are no previous jobs with exactly the same panel construction in the database, the program will find the closest, or **best-matching** jobs, using weighted-value search parameters. The report will indicate the differences, compared to the current job, and provide the **best-match** scale factors. As more data is collected over time, scaling targets become tighter, and scaling error is eliminated as a factor in multi-layer registration.

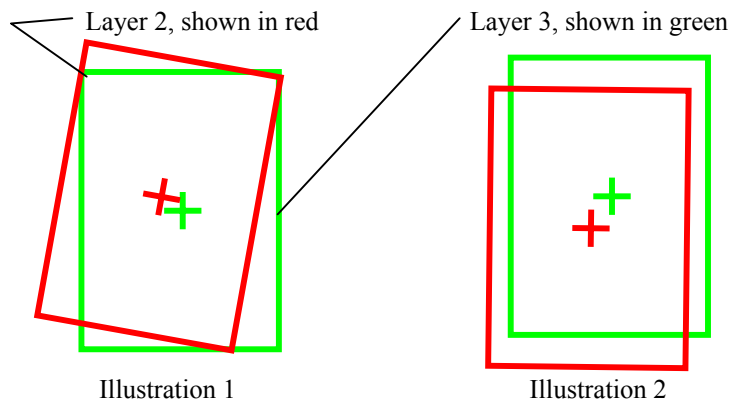
In both illustrations at left, there is a ***front-to-back registration shift error***. This shift error can only occur during dry-film imaging of these inner layer cores. When the dry-film imaging process is completed, the position/relationship between layers 2 & 3 is permanently fixed.
